Northern Cities Management Area 2017 Annual Monitoring Report

The Northern Cities Management Area Technical Group

April 22, 2018

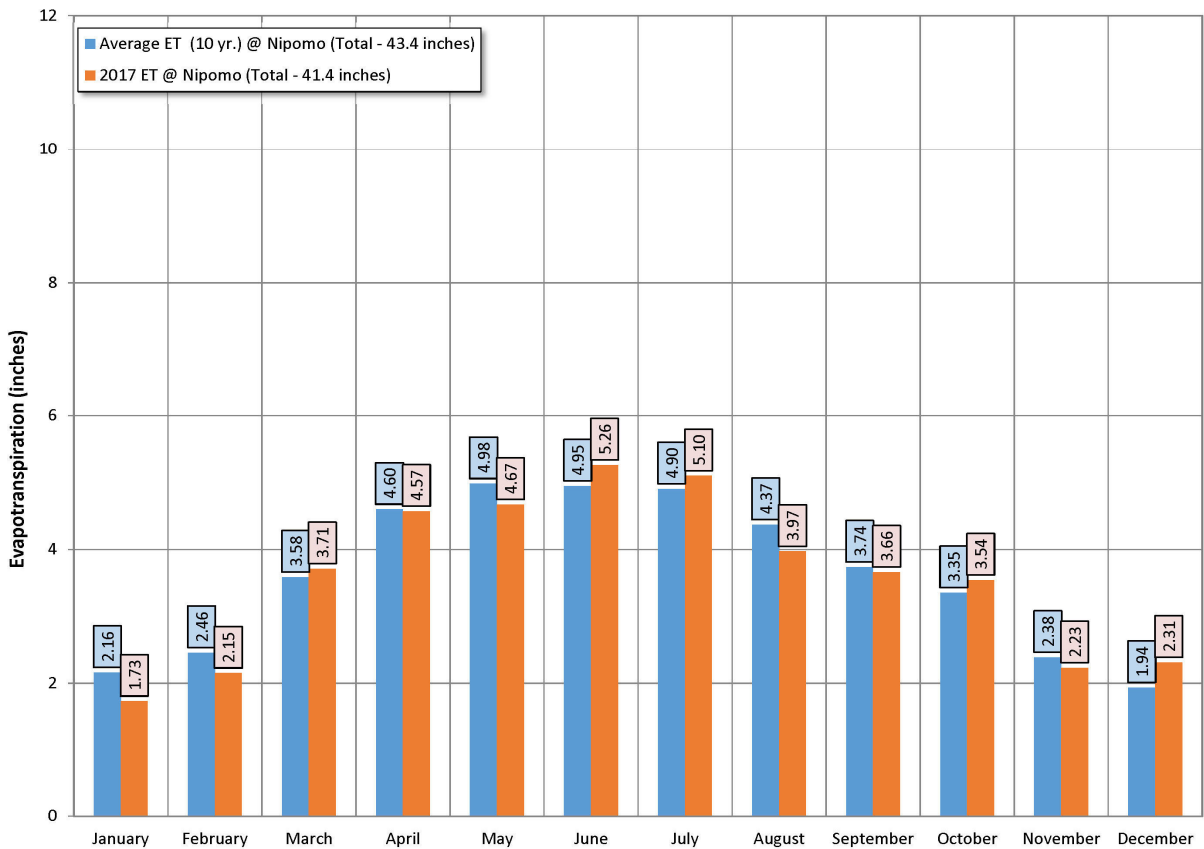
FIGURE 5

MONTHLY 2017 AND AVERAGE PRECIPITATION AND EVAPOTRANSPIRATION
 Northern Cities Management Area
 San Luis Obispo County, California

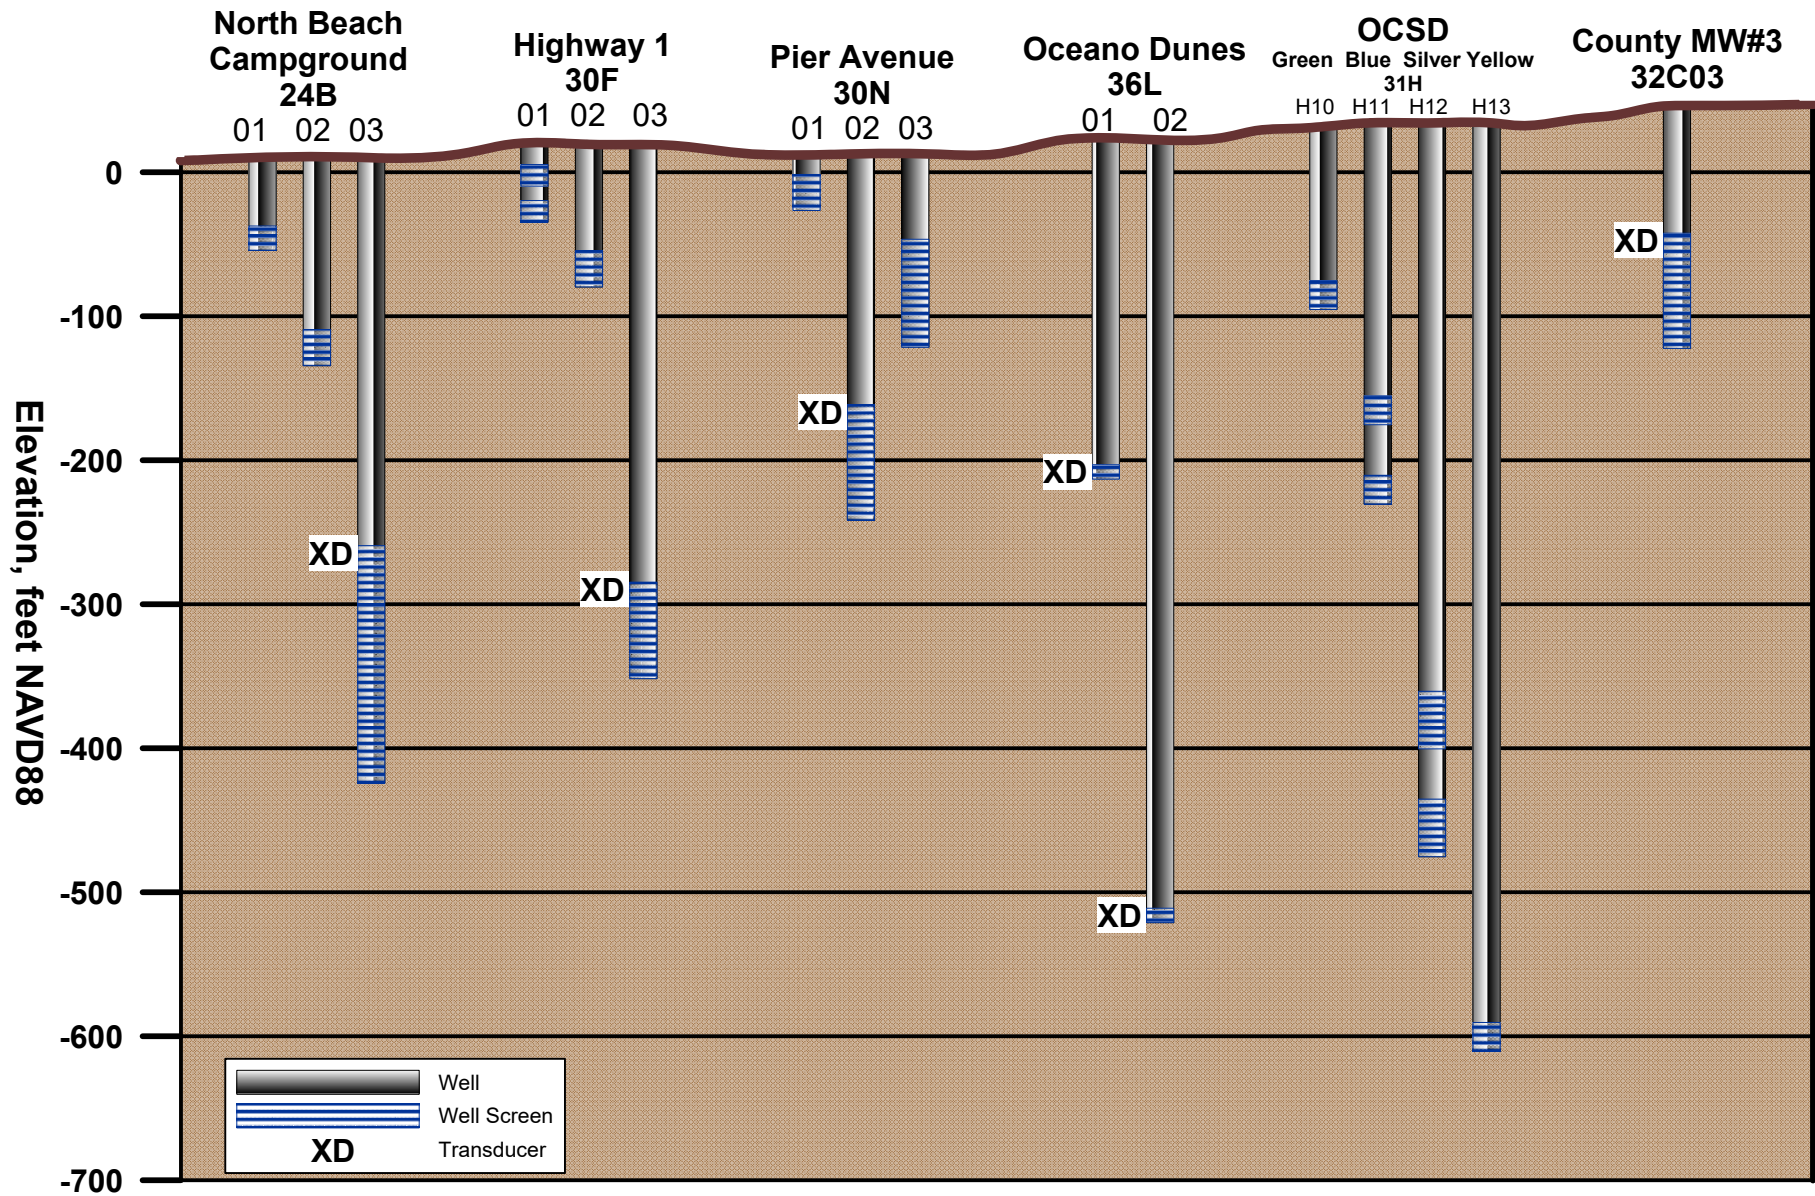
FIGURE 7

DEPTHS OF MONITORING WELLS
 Northern Cities Management Area
 San Luis Obispo County, California

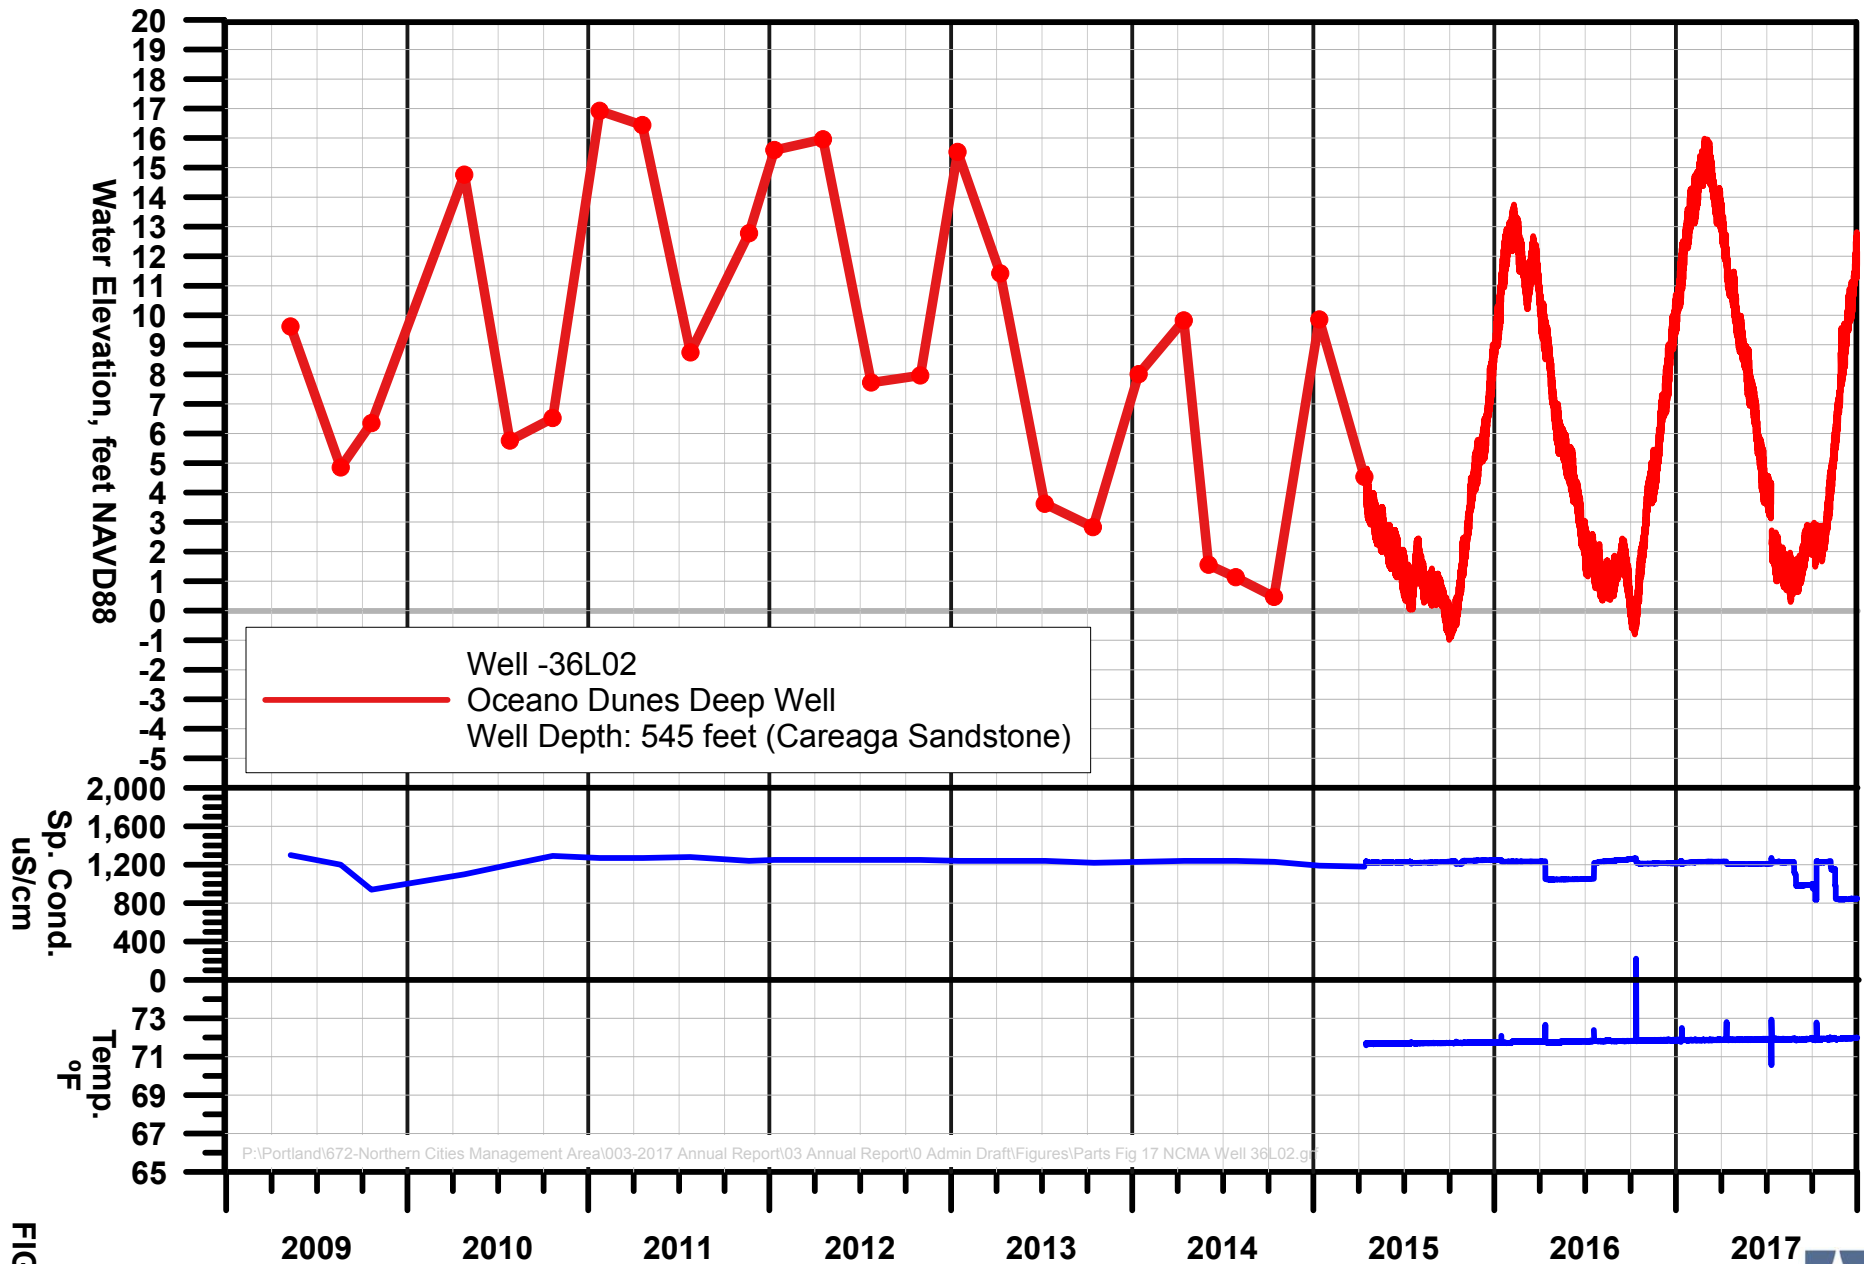
FIGURE 17

WATER ELEVATION, CONDUCTIVITY, AND TEMPERATURE, WELL 36L02
 Northern Cities Management Area
 San Luis Obispo County, California

Key wells (24B03, 30F03, 30N02, 36L01, 36L02, and 32C03) are instrumented with pressure transducers equipped with conductivity probes that periodically record water level, water temperature, and conductivity (Figures 13 through 18). (Note that transducer malfunctions in early to mid-2015 resulted in variable conductivity data in some of the wells; all transducers were replaced and are working properly). Wells 24B03, 30F03, and 30N02 comprise the wells used to calculate the Deep Well Index. Wells 36L01 and 36L02 are adjacent the coast. Well 32C03 is the easternmost well and adjacent to the boundary between the NCMA and NMMA. The following discusses 2017 water levels for these key wells:

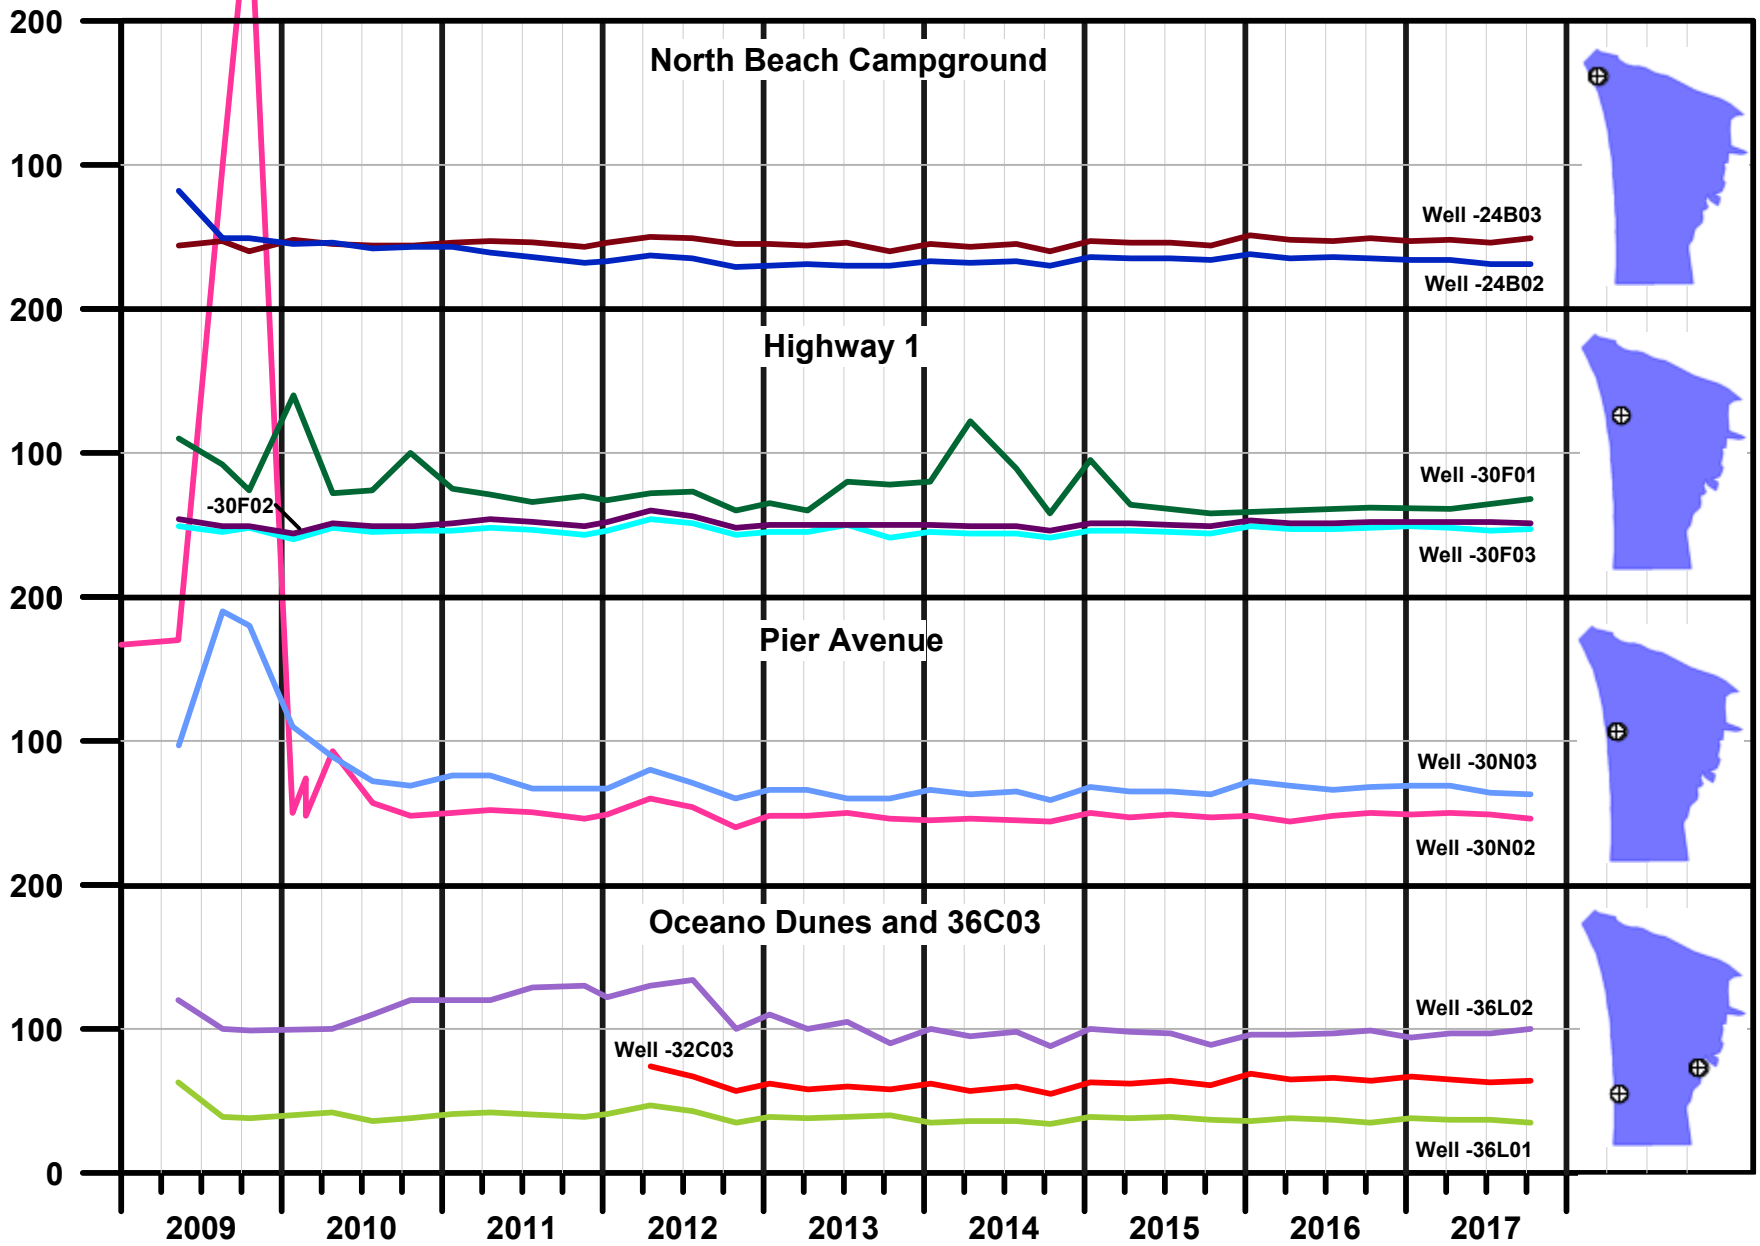
FIGURE 20

CHLORIDE CONCENTRATIONS IN MONITORING WELLS
Northern Cities Management Area
San Luis Obispo County, California

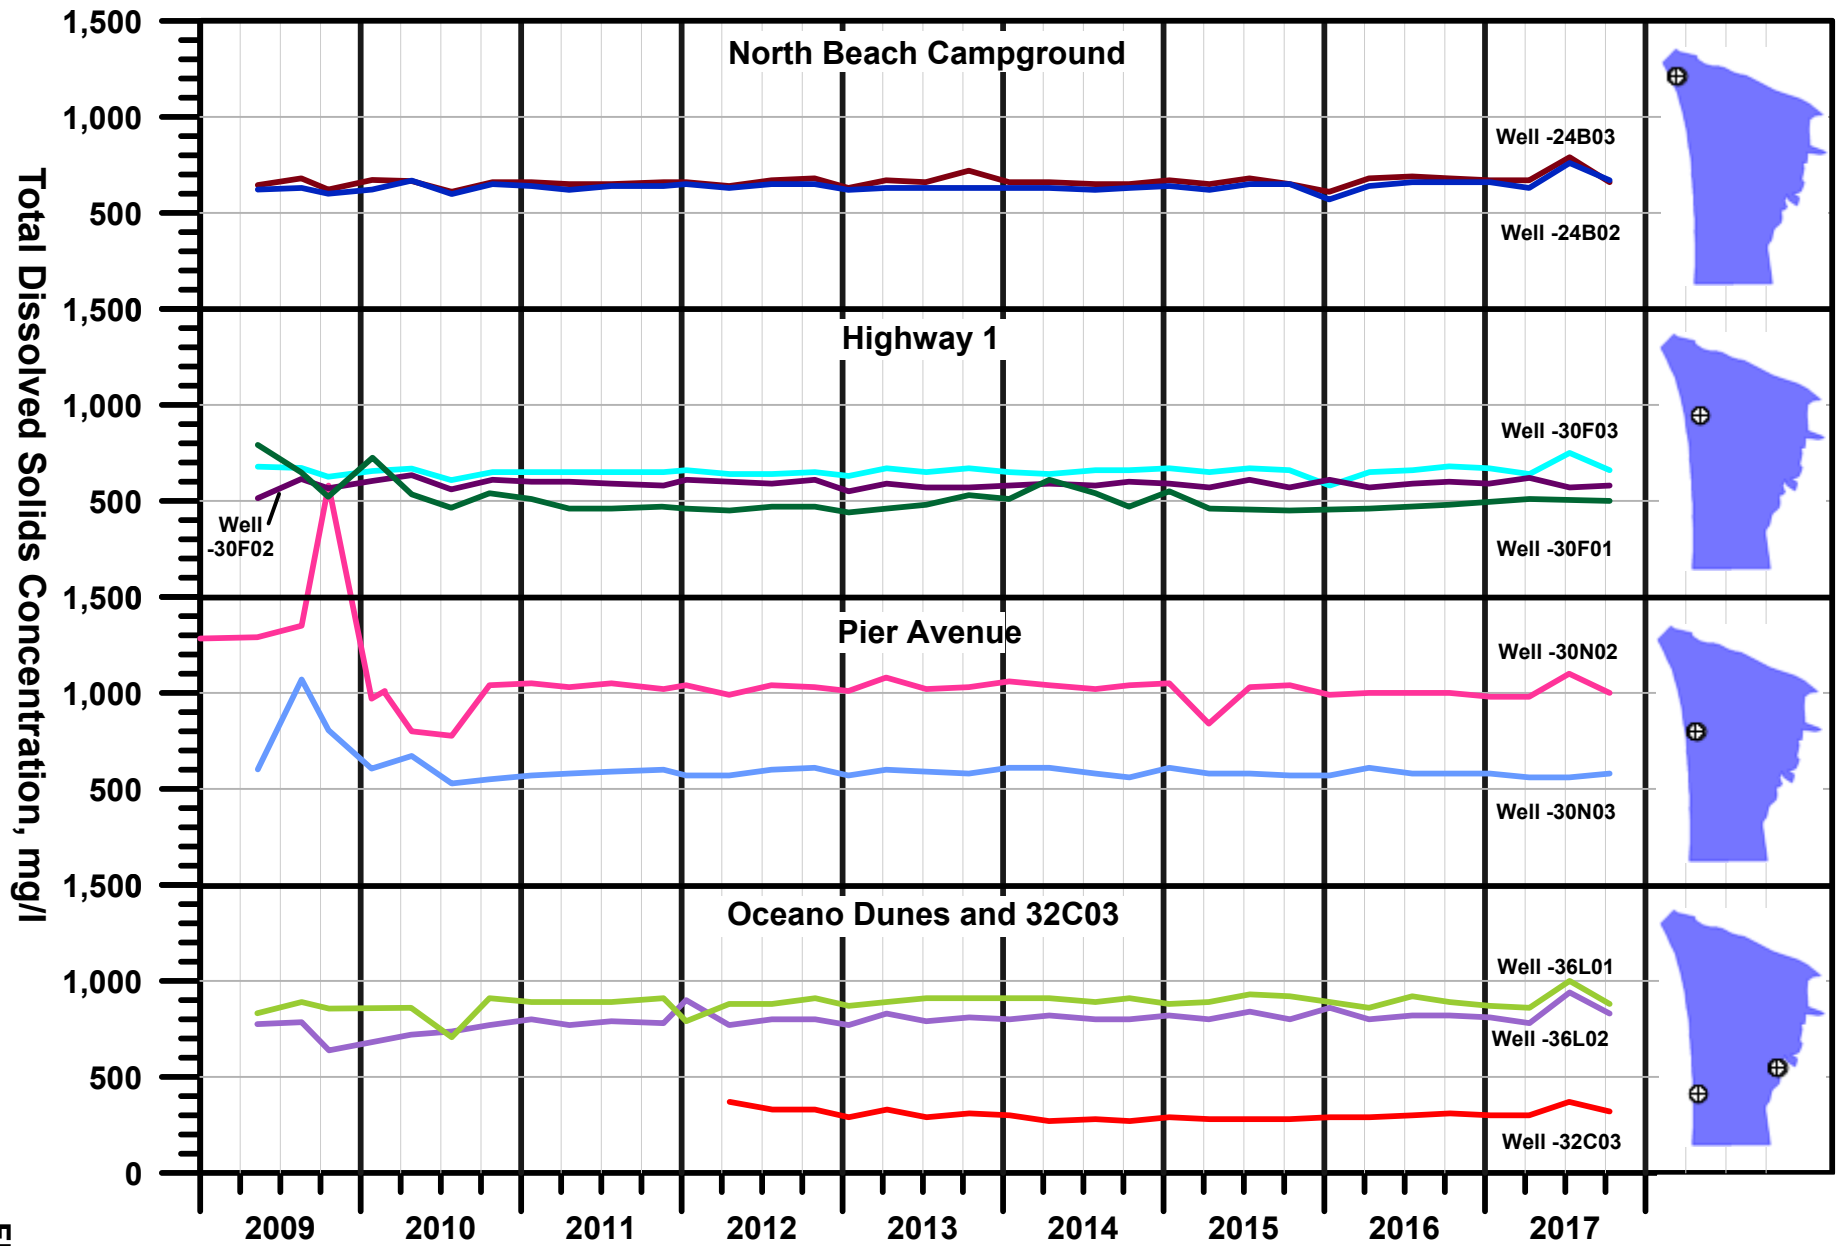
FIGURE 21

TOTAL DISSOLVED SOLIDS CONCENTRATIONS IN MONITORING WELLS
 Northern Cities Management Area
 San Luis Obispo County, California
